05 - STRUCTURES INDEX OF DRAWINGS

SUBSTRUCTURE CONCRETE REPAIRS IN DISTRICT 2

SUBSET COVER SHEET INDEX OF DRAWINGS-1

172-417
DRAWING NO.
S-01

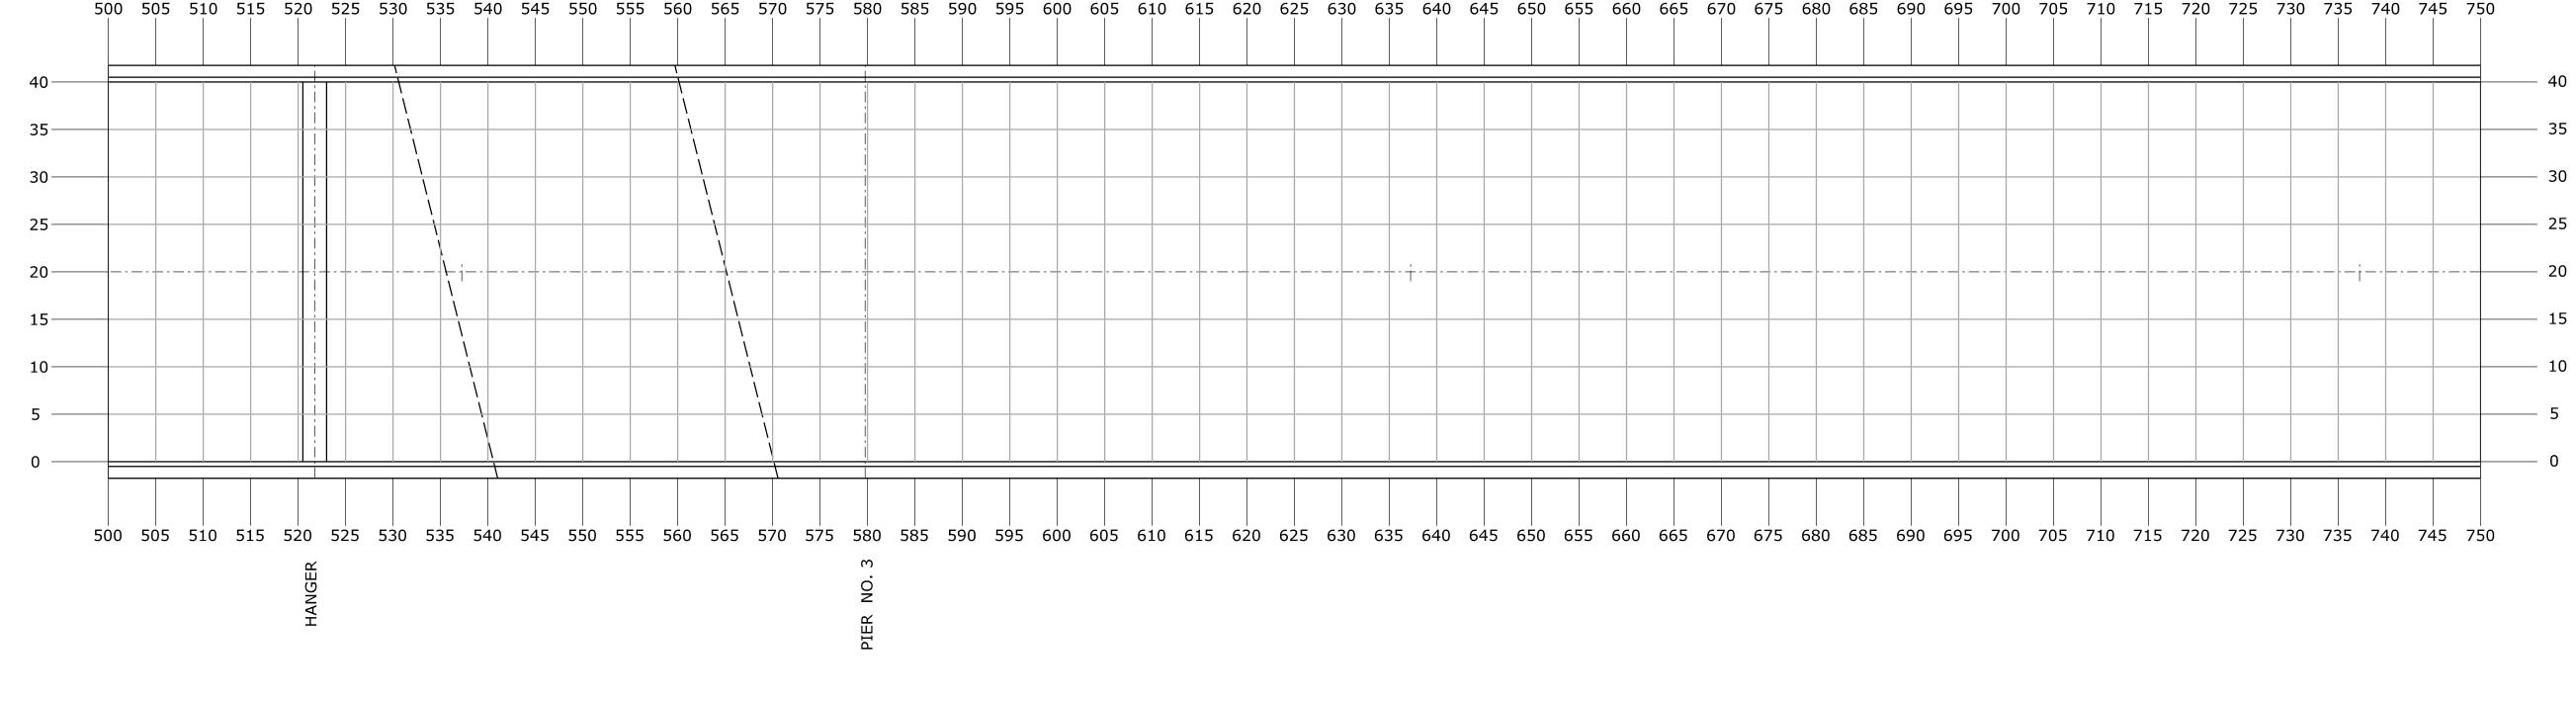
PARTIAL PLAN

- 1. THE BEGINNING AND COMPLETION DATES OF REPAIRS.
- 2. THE LIMITS OF EXISTING AND FINISHED PATCHED DECK AREAS ON THE PLAN USING THE PATTERN SHOWN IN THE DECK PATCHING LEGEND. (SEE EXAMPLE PLAN)
- 3. THE APPROXIMATE PERCENTAGE OF TOTAL DECK AREA REPAIRED WITH PARTIAL AND FULL DEPTH PATCHES.
- 4. THE FINAL QUANTITIES OF PARTIAL AND FULL DEPTH PATCHING MATERIALS USED IN THE DECK REPAIRS.
- 5. THE METHOD AND LIMIT OF REMOVAL OF THE DETERIORATED CONCRETE FOR EXAMPLE PNEUMATIC HAMMER OR HYDRO-DEMOLITION AS INDICATED ON THE DECK PLAN.
- 6. THE BRAND OF PATCHING MATERIAL USED AT EACH LOCATION ON THE DECK (DURACAL, CLASS "F" CONCRETE, ETC.) AS SHOWN IN THE EXAMPLE PLAN.

SCALE: 1" = 10'

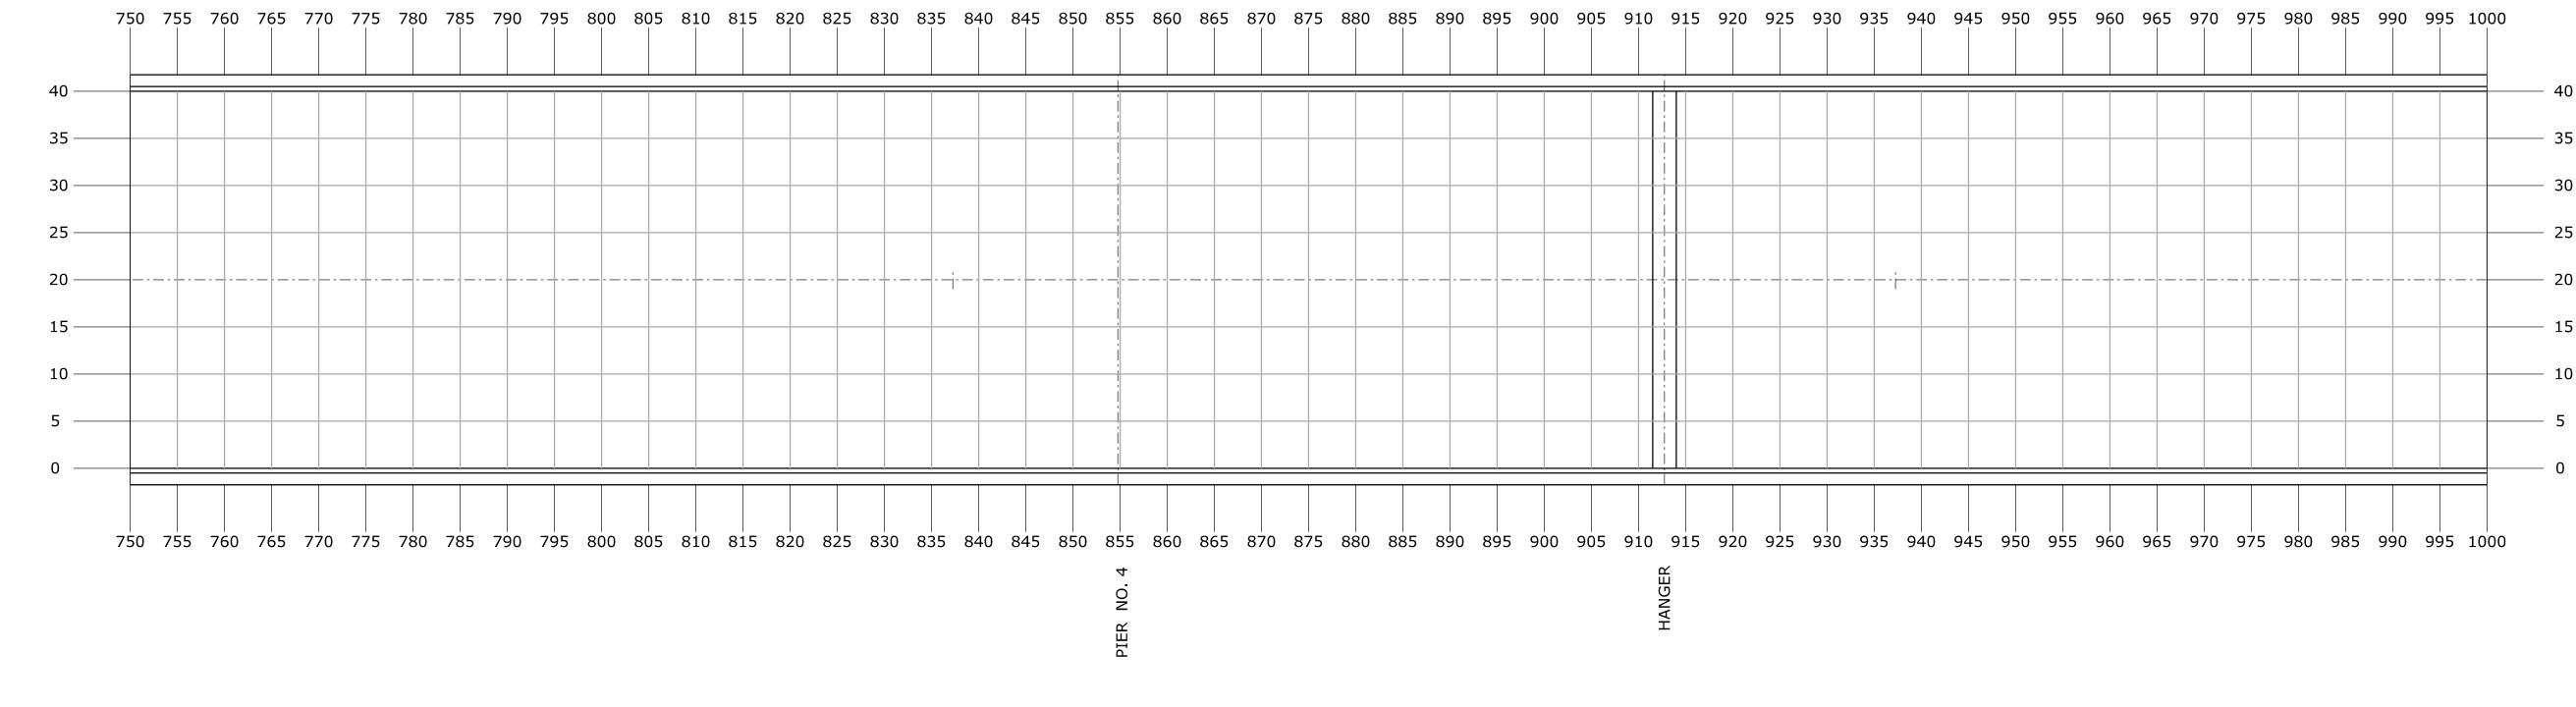
PARTIAL PLAN

- 1. THE BEGINNING AND COMPLETION DATES OF REPAIRS.
- 2. THE LIMITS OF EXISTING AND FINISHED PATCHED DECK AREAS ON THE PLAN USING THE PATTERN SHOWN IN THE DECK PATCHING LEGEND. (SEE EXAMPLE PLAN)
- 3. THE APPROXIMATE PERCENTAGE OF TOTAL DECK AREA REPAIRED WITH PARTIAL AND FULL DEPTH PATCHES.
- 4. THE FINAL QUANTITIES OF PARTIAL AND FULL DEPTH PATCHING MATERIALS USED IN THE DECK REPAIRS.
- 5. THE METHOD AND LIMIT OF REMOVAL OF THE DETERIORATED CONCRETE FOR EXAMPLE PNEUMATIC HAMMER OR HYDRO-DEMOLITION AS INDICATED ON THE DECK PLAN.
- 6. THE BRAND OF PATCHING MATERIAL USED AT EACH LOCATION ON THE DECK (DURACAL, CLASS "F" CONCRETE, ETC.) AS SHOWN IN THE EXAMPLE PLAN.

SCALE: 1" = 10'

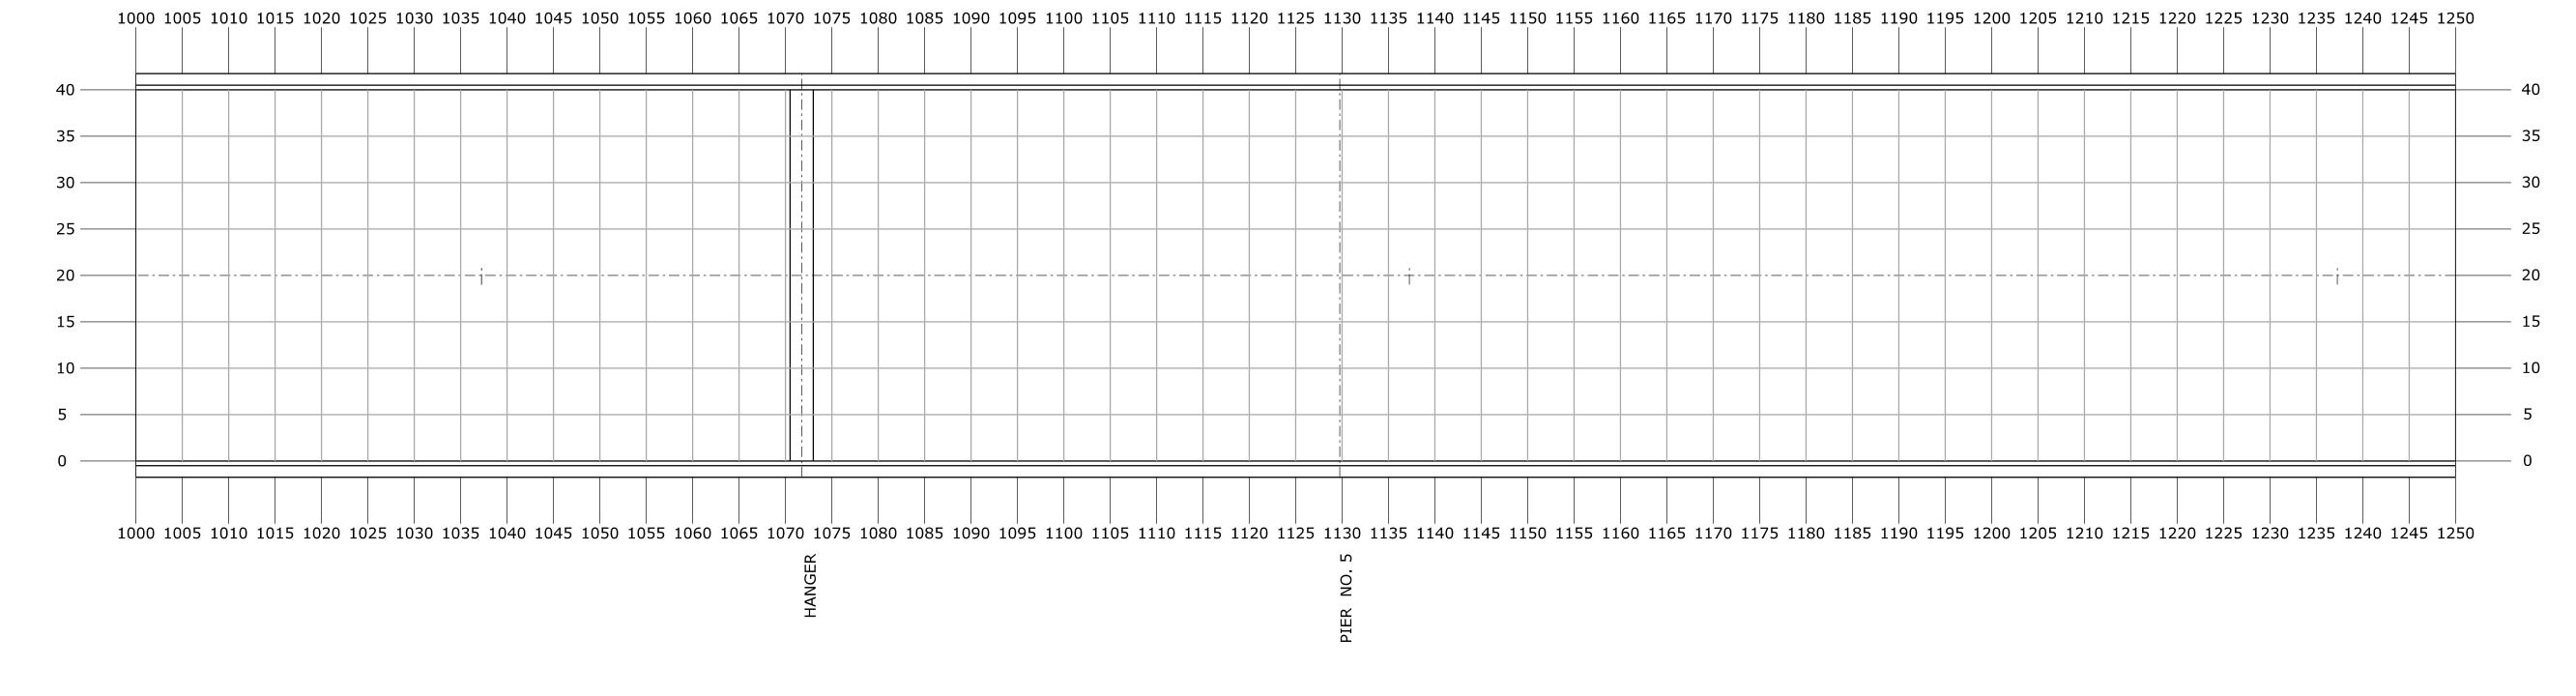
PARTIAL PLAN

- 1. THE BEGINNING AND COMPLETION DATES OF REPAIRS.
- 2. THE LIMITS OF EXISTING AND FINISHED PATCHED DECK AREAS ON THE PLAN USING THE PATTERN SHOWN IN THE DECK PATCHING LEGEND. (SEE EXAMPLE PLAN)
- 3. THE APPROXIMATE PERCENTAGE OF TOTAL DECK AREA REPAIRED WITH PARTIAL AND FULL DEPTH PATCHES.
- 4. THE FINAL QUANTITIES OF PARTIAL AND FULL DEPTH PATCHING MATERIALS USED IN THE DECK REPAIRS.
- 5. THE METHOD AND LIMIT OF REMOVAL OF THE DETERIORATED CONCRETE FOR EXAMPLE PNEUMATIC HAMMER OR HYDRO-DEMOLITION AS INDICATED ON THE DECK PLAN.
- 6. THE BRAND OF PATCHING MATERIAL USED AT EACH LOCATION ON THE DECK (DURACAL, CLASS "F" CONCRETE, ETC.) AS SHOWN IN THE EXAMPLE PLAN.

SCALE: 1'' = 10'

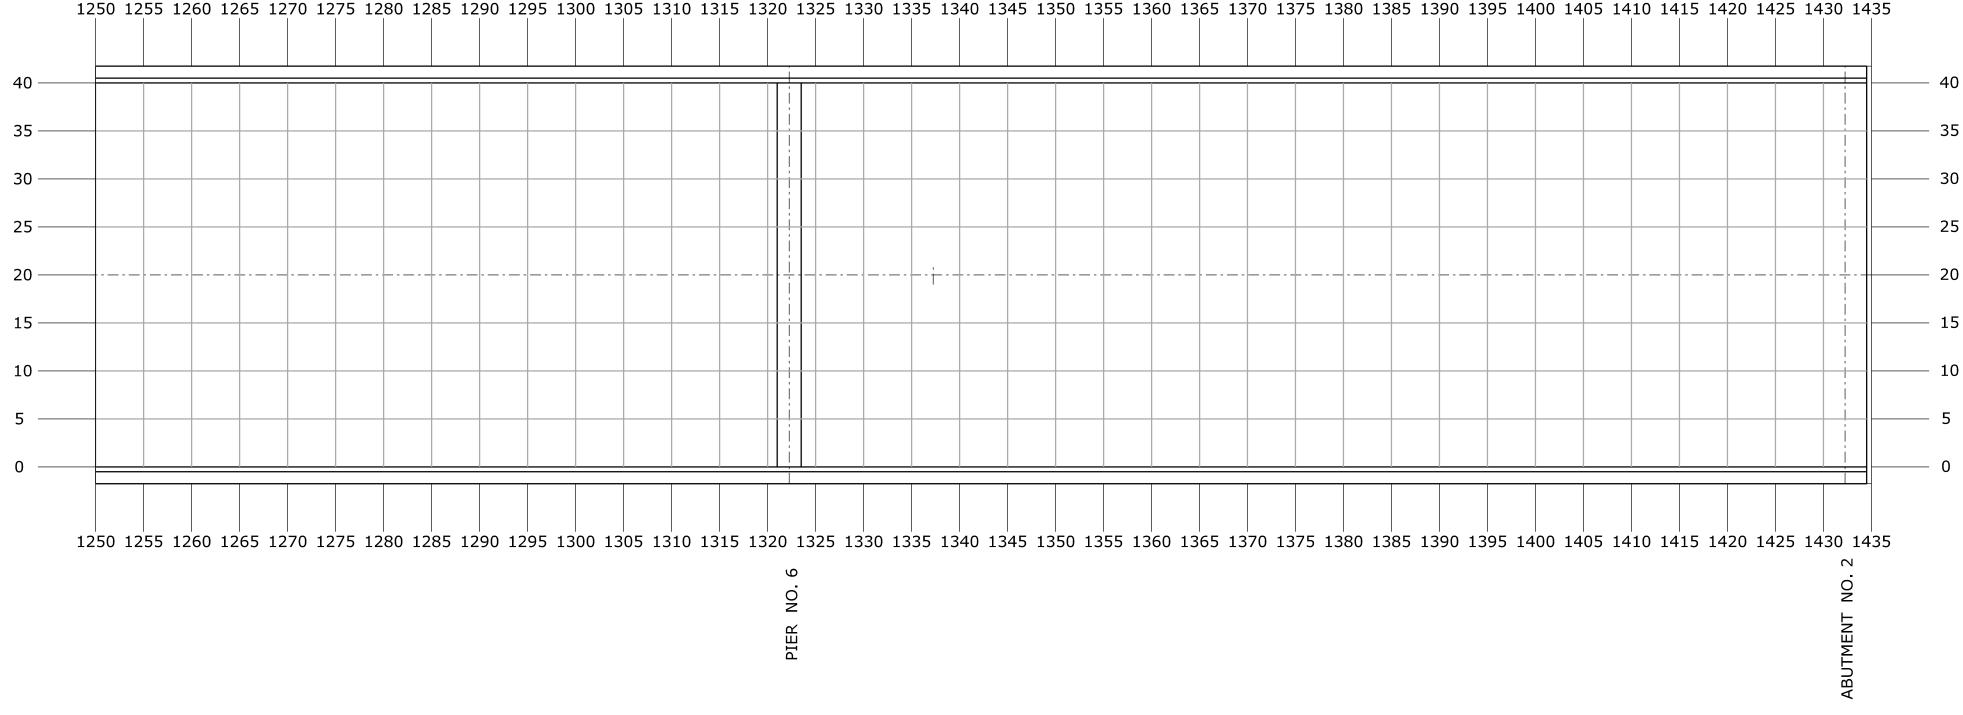
PARTIAL PLAN

- 1. THE BEGINNING AND COMPLETION DATES OF REPAIRS.
- 2. THE LIMITS OF EXISTING AND FINISHED PATCHED DECK AREAS ON THE PLAN USING THE PATTERN SHOWN IN THE DECK PATCHING LEGEND. (SEE EXAMPLE PLAN)
- 3. THE APPROXIMATE PERCENTAGE OF TOTAL DECK AREA REPAIRED WITH PARTIAL AND FULL DEPTH PATCHES.
- 4. THE FINAL QUANTITIES OF PARTIAL AND FULL DEPTH PATCHING MATERIALS USED IN THE DECK REPAIRS.
- 5. THE METHOD AND LIMIT OF REMOVAL OF THE DETERIORATED CONCRETE FOR EXAMPLE PNEUMATIC HAMMER OR HYDRO-DEMOLITION AS INDICATED ON THE DECK PLAN.
- 6. THE BRAND OF PATCHING MATERIAL USED AT EACH LOCATION ON THE DECK (DURACAL, CLASS "F" CONCRETE, ETC.) AS SHOWN IN THE EXAMPLE PLAN.

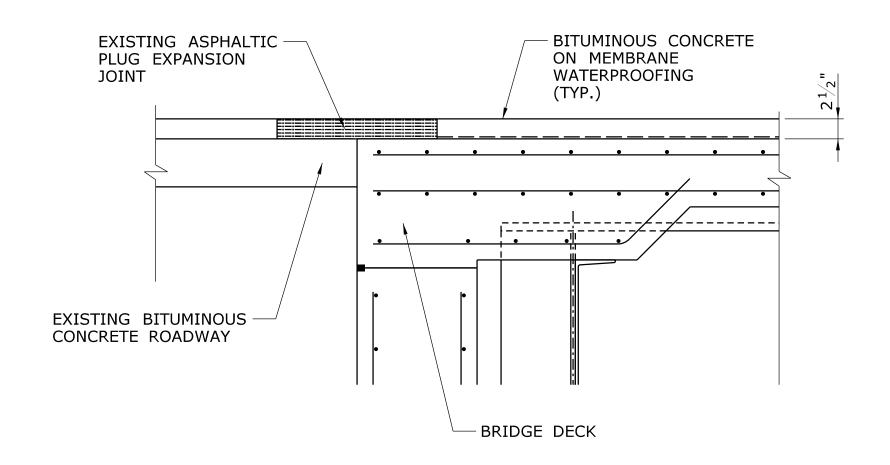
REMOVE EXISTING ASPHALTIC PLUG EXPANSION JOINT BRIDGE DECK EXISTING 1" X 1" JOINT SEAL

EXISTING STRIP SEAL WITH — BITUMINOUS CONCRETE CONCRETE HEADERS ON MEMBRANE WATERPROOFING $\frac{3}{4}$ " SAWCUT (TYP.) -(TYP.) LIMITS OF CONCRETE REMOVAL ·--/--/------— BRIDGE DECK BRIDGE DECK - EXISTING REINFORCEMENT TO REMAIN (TYP.) **NOTES:** LIMITS OF CONCRETE ALL DIMENSION THAT REFER TO EXISTING REMOVAL CONSTRUCTION SHALL BE VERIFIED AT THE SITE BY THE CONTRACTOR.

CONCRETE REMOVAL AND RECONSTRUCTION
WORK SHALL BE PAID FOR UNDER THE ITEM
"SILICONE EXPANSION JOINT SYSTEM".

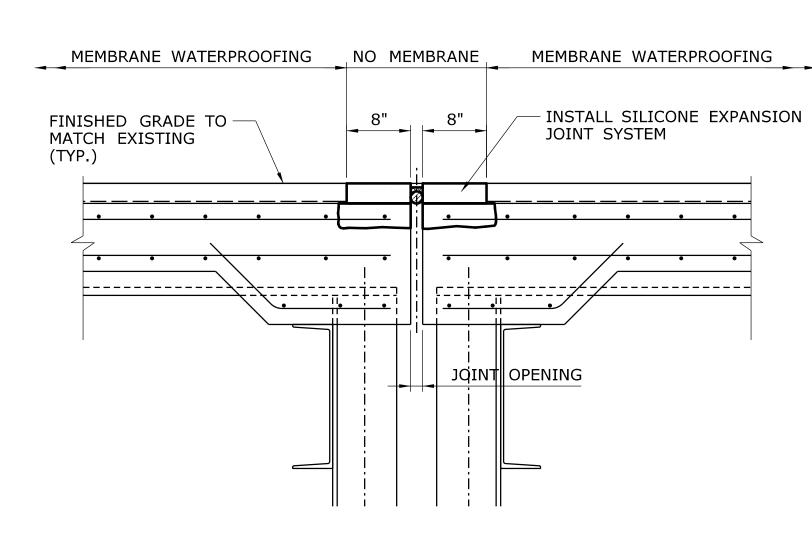
JOINT REPLACEMENT AT FIXED
PIN AND HANGER LOCATIONS

THE DESIGN THERMAL MOVEMENT AT FIXED PIN AND HANGER LOCATIONS IS 0".

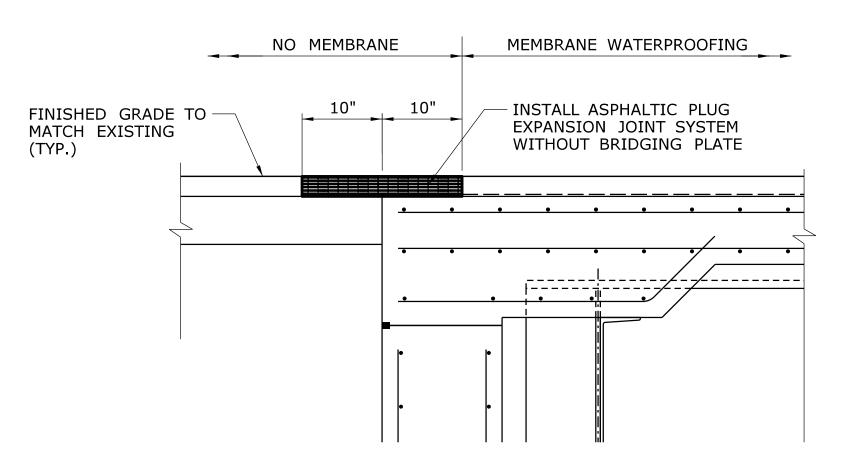
JOINT REPLACEMENT AT ABUTMENTS

THE DESIGN THERMAL MOVEMENT AT ABUTMENT NOS. 1 & 2 IS 0".

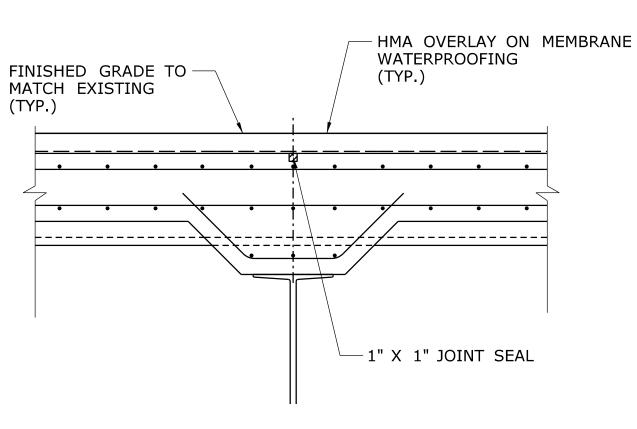
REPLACE MISSING OR DETERIORATED 1" X 1" JOINT SEAL. THIS WORK SHALL BE PAID FOR UNDER THE ITEM "CLEAN AND RESEAL EXISTING FILLED BRIDGE JOINTS".

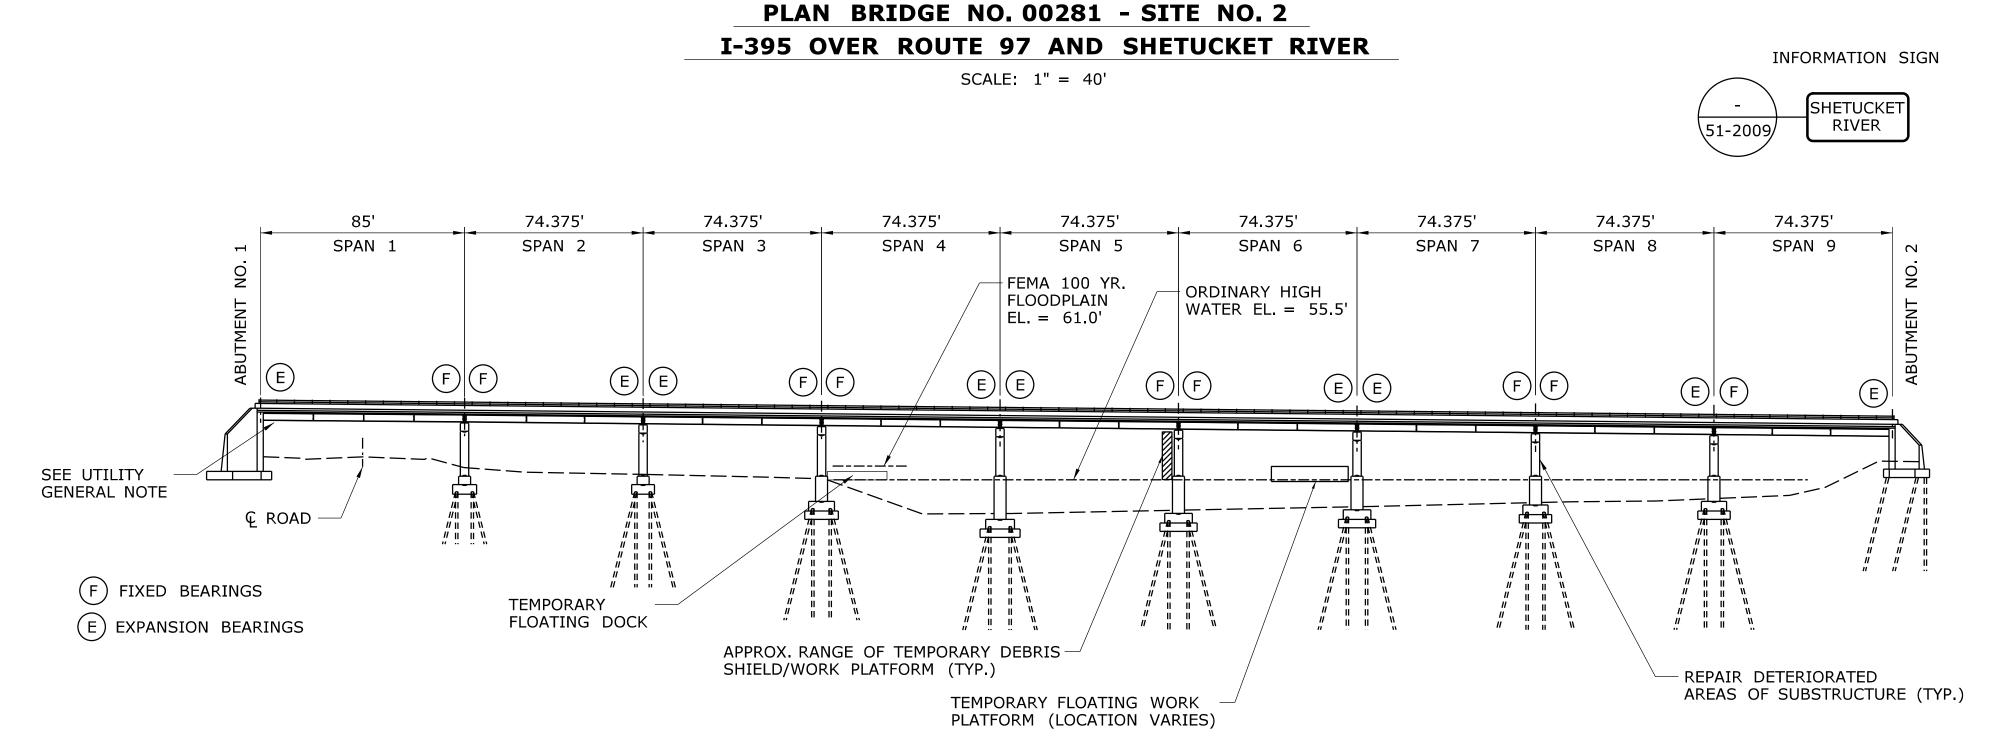
- 1. FLOODWAY AND FLOODPLAIN TO THE EAST EXTENDS BEYOND LIMITS OF THIS PLAN.
- 2. VERTICAL DATUM BASED ON NGVD 29.
- 3. ALL REPAIRS SHALL BE ABOVE THE ORDINARY HIGH WATER ELEVATION.
- 4. FLOATING WORK PLATFORMS MAY BE UTILIZED AT VARIOUS LOCATIONS SHOWN TO PERFORM CONCRETE REPAIRS AT THE PIERS. FLOATING PLATFORM SIZES VARY AND ARE NOT DRAWN TO SCALE.
- 5. ALL TEMPORARY FACILITIES AND EQUIPMENT BELOW THE 100 YEAR FLOOD ELEVATION WILL BE SUBJECT TO REMOVAL IN THE EVENT OF A FLOOD WARNING. THIS REMOVAL SHALL BE PERFORMED UNDER AN APPROPRIATE EVACUATION PLAN TO BE APPROVED BY THE ENGINEER.

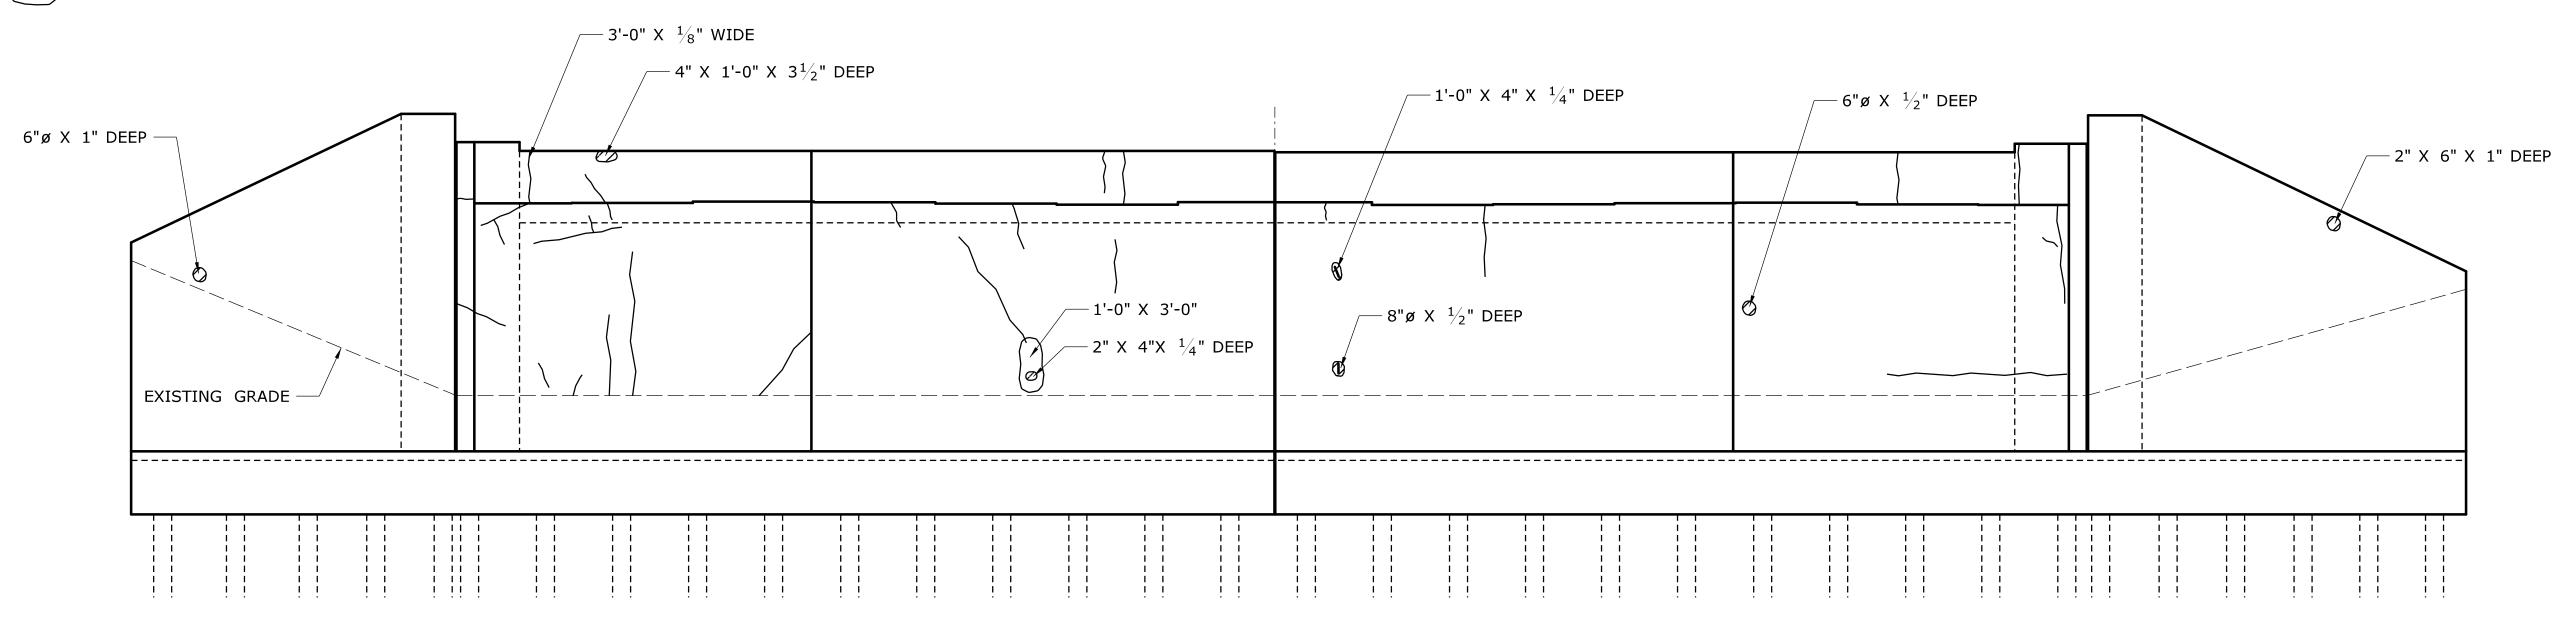
ABUTMENT NO. 2

1. THE SUBSTRUCTURE DETERIORATION AND REPAIR DIMENSIONS SHOWN ARE BASED ON LIMITED FIELD OBSERVATIONS AND BRIDGE SAFETY INSPECTION REPORT (10/25/2010). THE INFORMATION IS INTENDED TO BE USED AS A GUIDE AND DOES NOT NECESSARILY REFLECT THE CURRENT CONDITION OF THE STRUCTURE. THE EXACT LOCATION AND LIMITS OF DETERIORATED CONCRETE TO BE REPAIRED SHALL BE DETERMINED BY THE ENGINEER DURING CONSTRUCTION.

4. SPALLS, HOLLOW AND SCALE AREAS SHALL BE REPAIRED IN ACCORDANCE WITH "SHALLOW PATCH REPAIR DETAIL" OR "DEEP PATCH REPAIR DETAIL" SHOWN ON DWG. NO. S-05.

5. MAXIMUM 15 LB PNEUMATIC HAMMER TO BE USED ADJACENT TO EXISTING REINFORCING TO REMAIN.

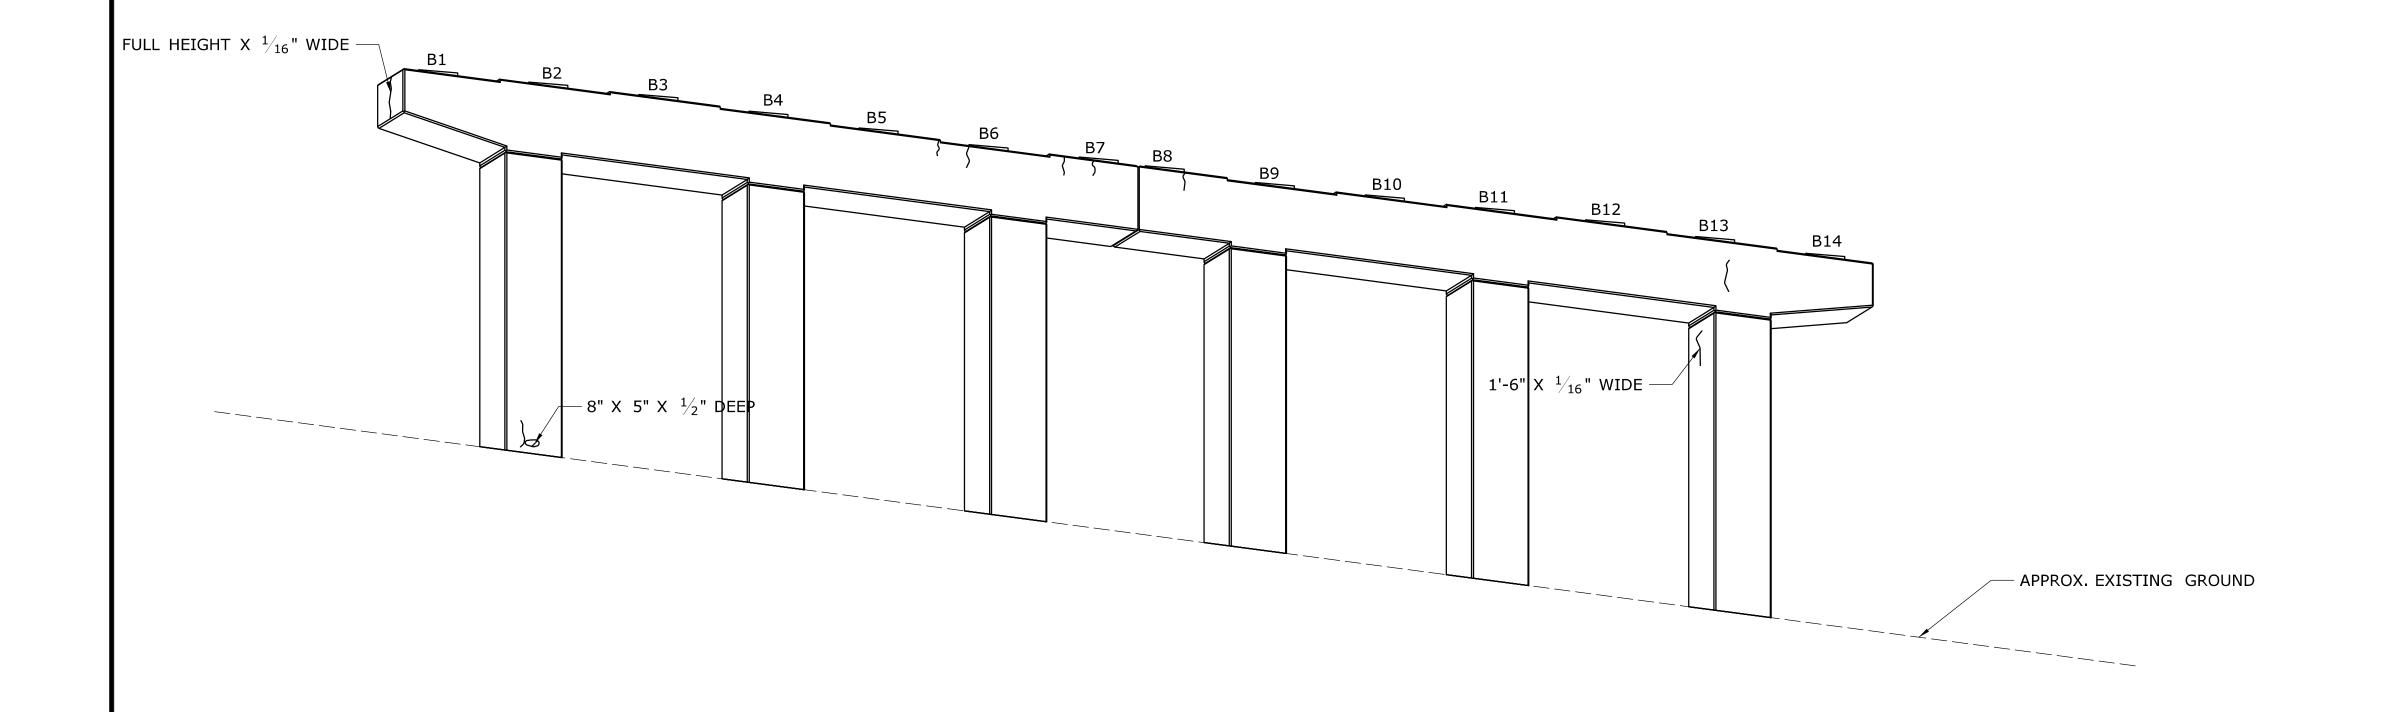
PIER 1 - WEST ELEVATION

- 1. THE SUBSTRUCTURE DETERIORATION AND REPAIR DIMENSIONS SHOWN ARE BASED ON LIMITED FIELD OBSERVATIONS AND BRIDGE SAFETY INSPECTION REPORT (10/25/2010). THE INFORMATION IS INTENDED TO BE USED AS A GUIDE AND DOES NOT NECESSARILY REFLECT THE CURRENT CONDITION OF THE STRUCTURE. THE EXACT LOCATION AND LIMITS OF DETERIORATED CONCRETE TO BE REPAIRED SHALL BE DETERMINED BY THE ENGINEER DURING CONSTRUCTION.

- 3. THE CONTRACTOR SHALL NOT PERFORM ANY REPAIR WORK WITHOUT PRIOR APPROVAL FROM THE ENGINEER.
- 4. SPALLS, HOLLOW AND SCALE AREAS SHALL BE REPAIRED IN ACCORDANCE WITH "SHALLOW PATCH REPAIR DETAIL" OR "DEEP PATCH REPAIR DETAIL" SHOWN ON DWG. NO. S-05.

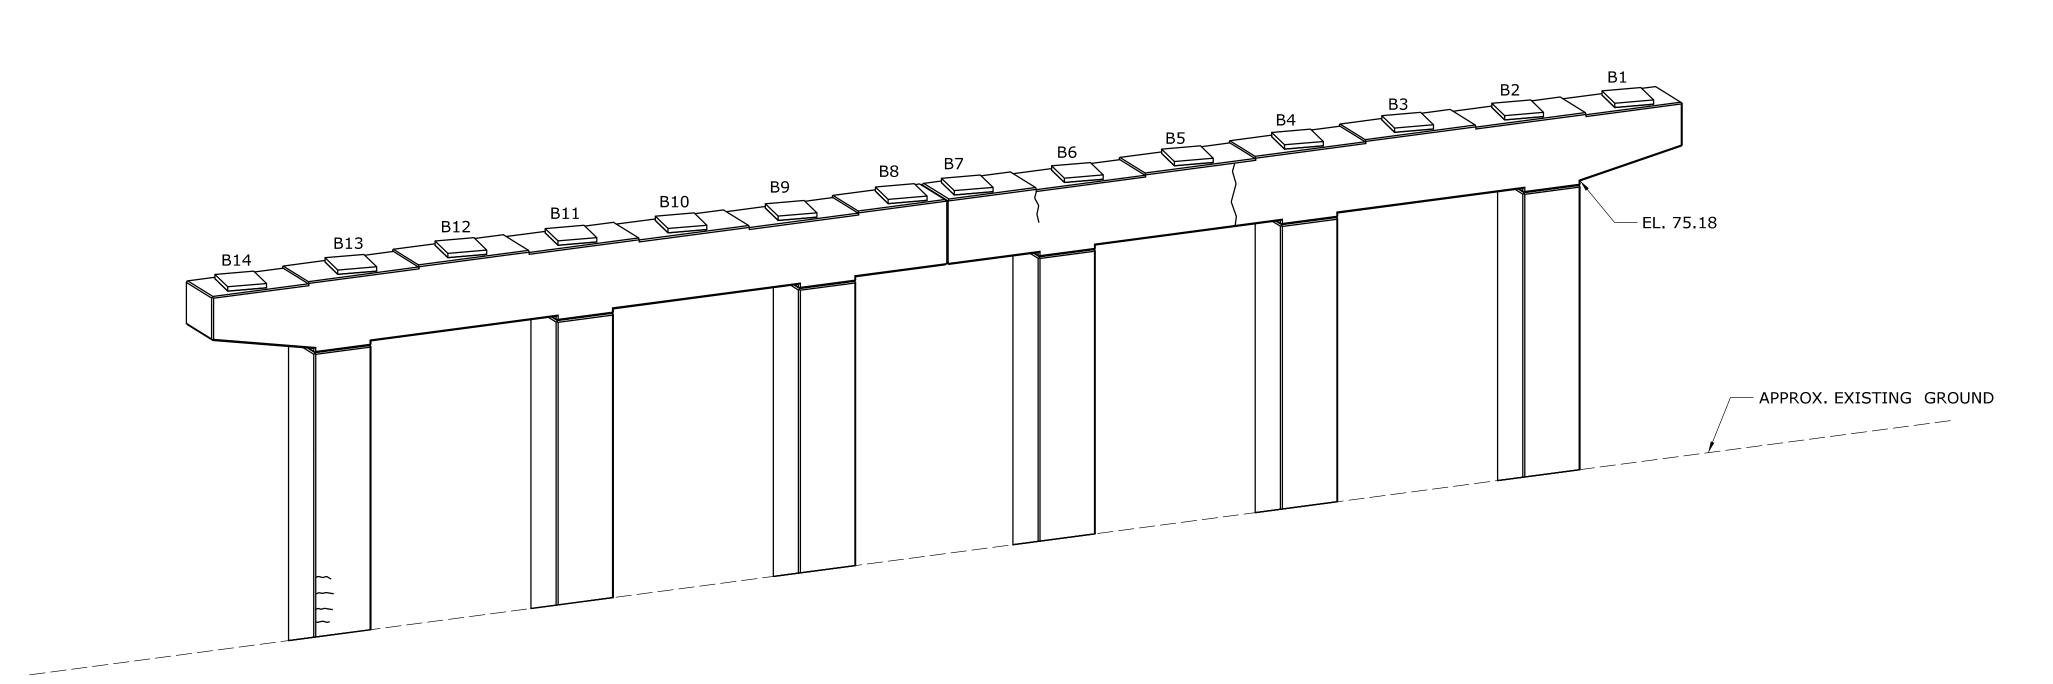
PIER 2 - EAST ELEVATION

1. THE SUBSTRUCTURE DETERIORATION AND REPAIR DIMENSIONS SHOWN ARE BASED ON LIMITED FIELD OBSERVATIONS AND BRIDGE SAFETY INSPECTION REPORT (10/25/2010), THE INFORMATION IS INTENDED TO BE USED AS A GUIDE AND DOES NOT NECESSARILY REFLECT THE CURRENT CONDITION OF THE STRUCTURE. THE EXACT LOCATION AND LIMITS OF DETERIORATED CONCRETE TO BE REPAIRED SHALL BE

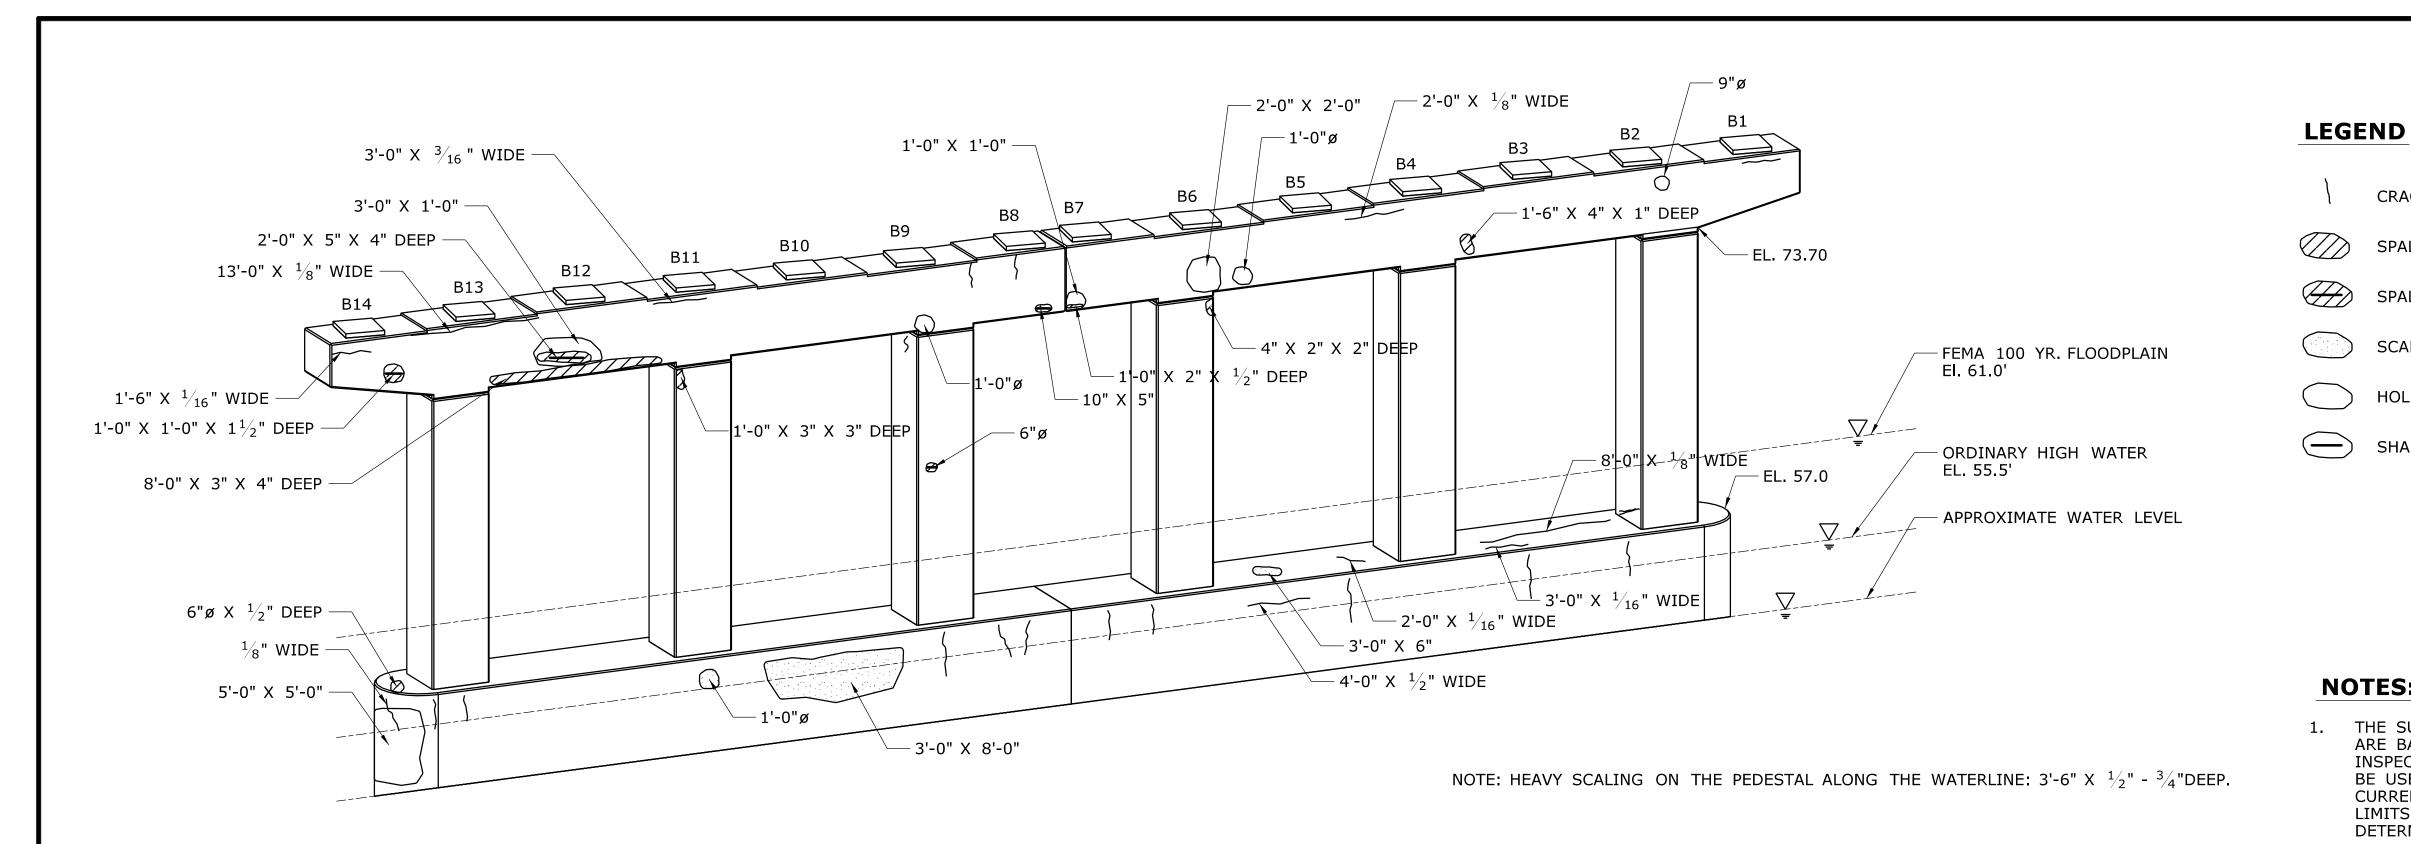
PIER 4 - EAST ELEVATION

THE SUBSTRUCTURE DETERIORATION AND REPAIR DIMENSIONS SHOWN ARE BASED ON LIMITED FIELD OBSERVATIONS AND BRIDGE SAFETY

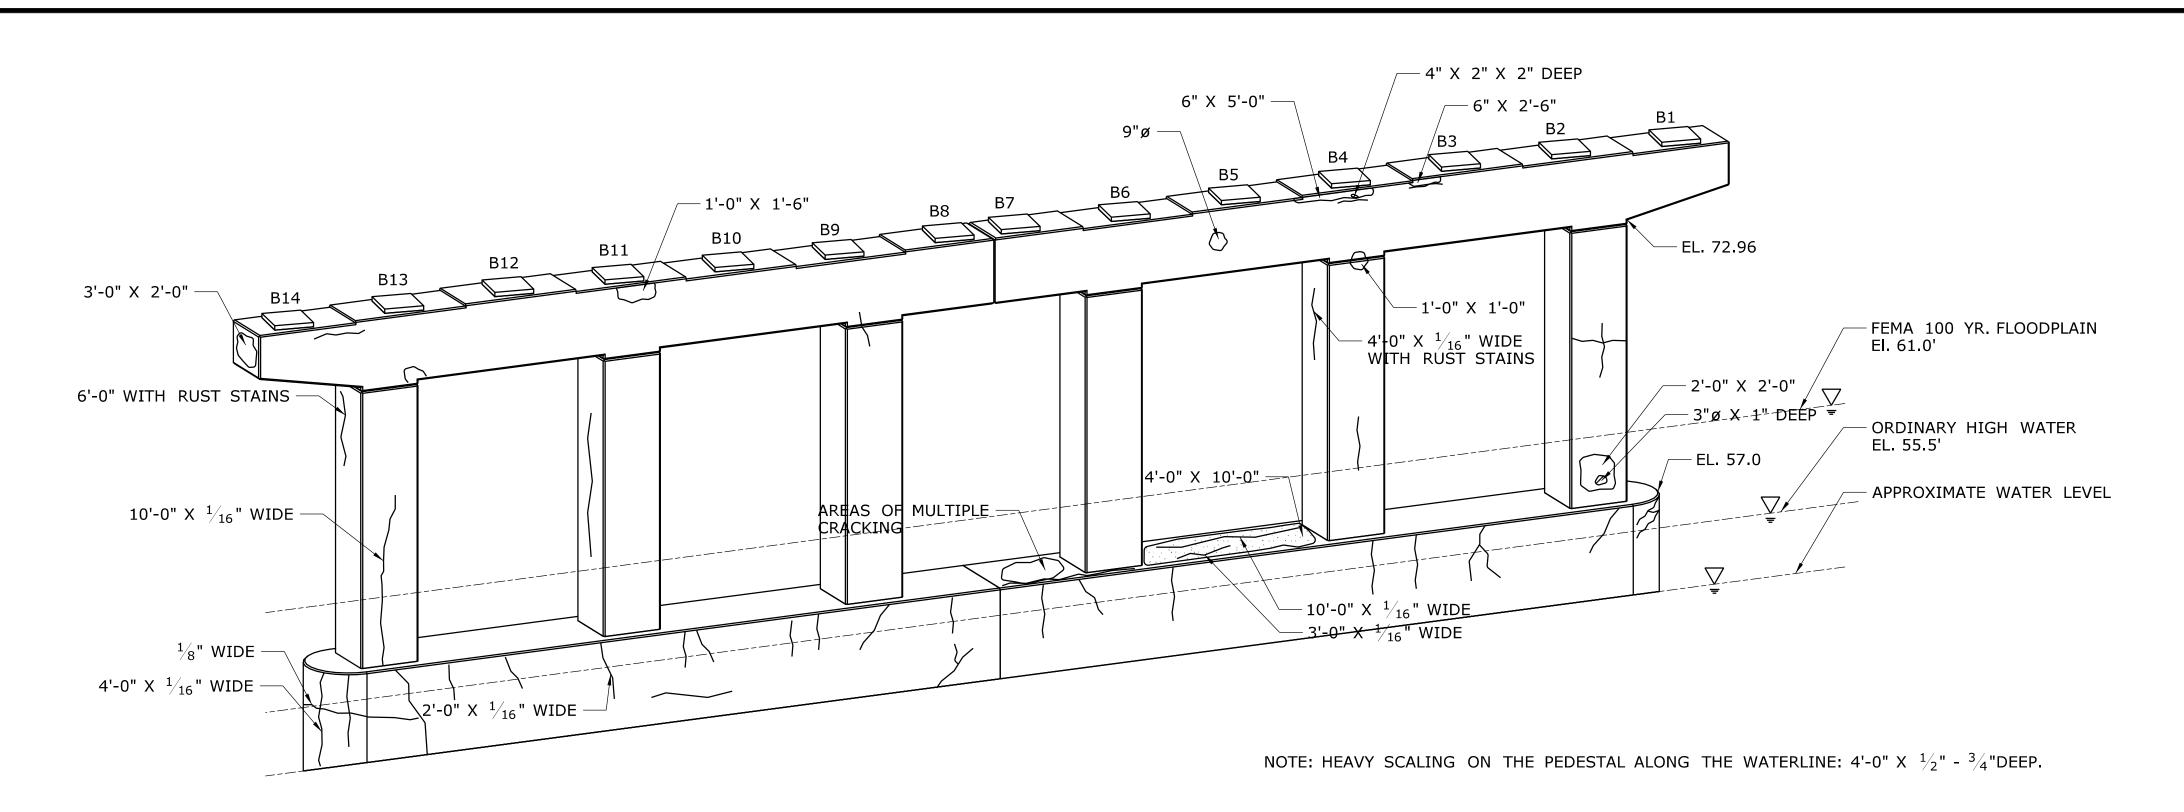
PIER 5 - EAST ELEVATION

1. THE SUBSTRUCTURE DETERIORATION AND REPAIR DIMENSIONS SHOWN ARE BASED ON LIMITED FIELD OBSERVATIONS AND BRIDGE SAFETY

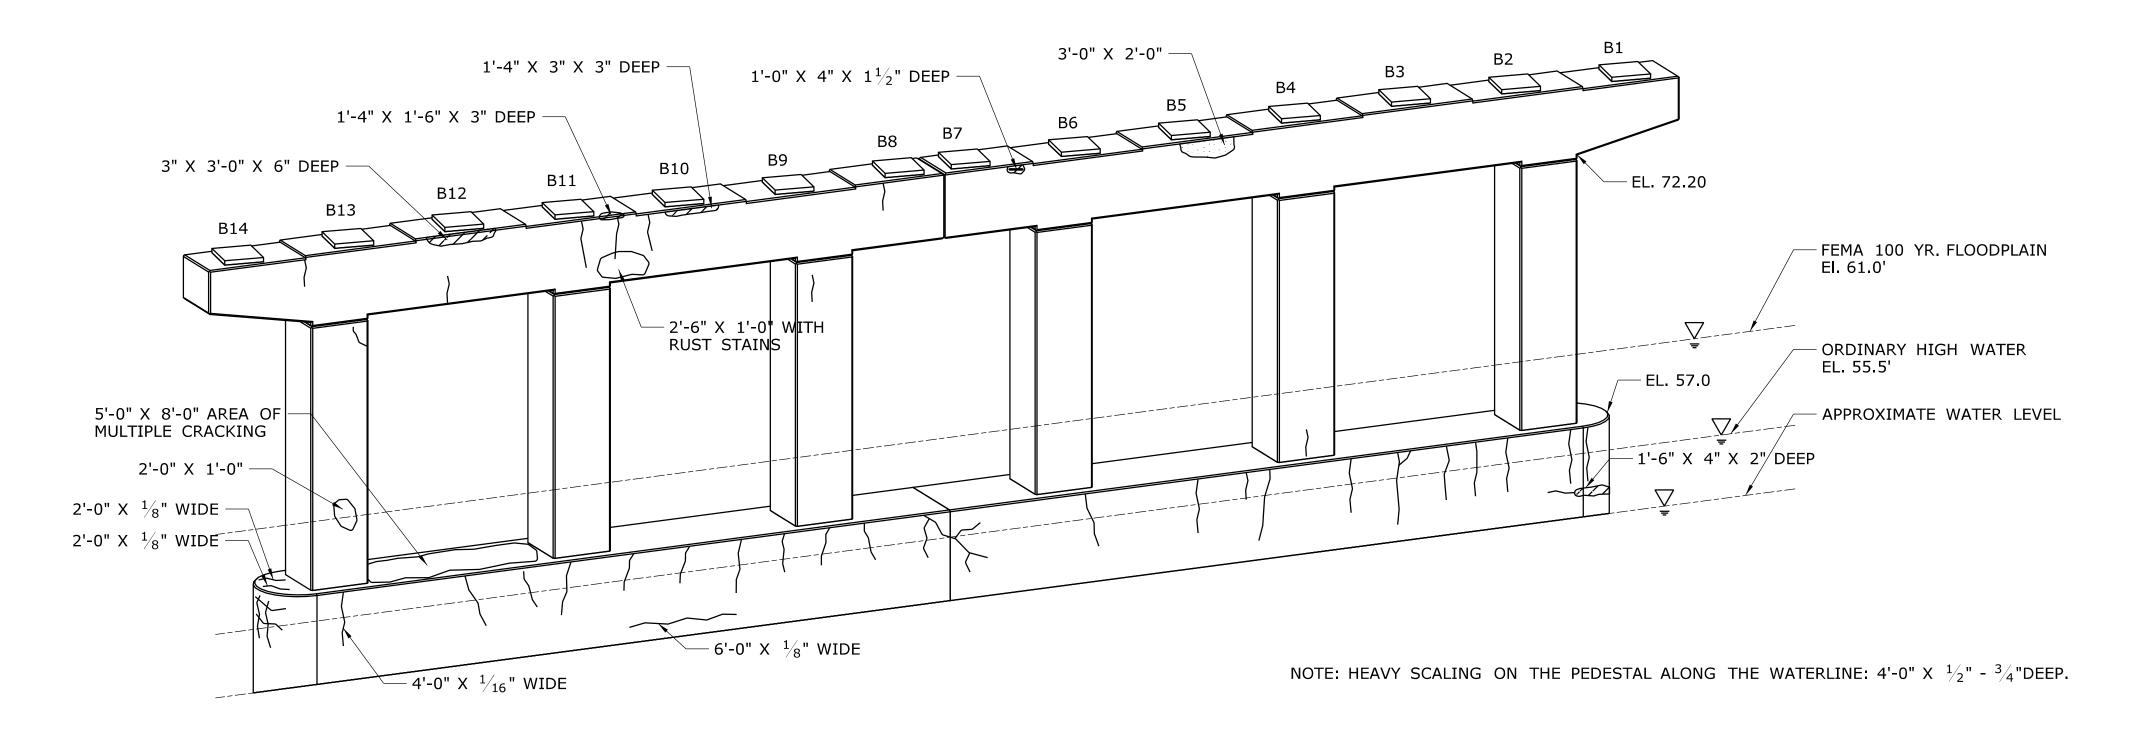
PIER 6 - EAST ELEVATION

- 1. THE SUBSTRUCTURE DETERIORATION AND REPAIR DIMENSIONS SHOWN ARE BASED ON LIMITED FIELD OBSERVATIONS AND BRIDGE SAFETY INSPECTION REPORT (10/25/2010). THE INFORMATION IS INTENDED TO BE USED AS A GUIDE AND DOES NOT NECESSARILY REFLECT THE CURRENT CONDITION OF THE STRUCTURE. THE EXACT LOCATION AND LIMITS OF DETERIORATED CONCRETE TO BE REPAIRED SHALL BE DETERMINED BY THE ENGINEER DURING CONSTRUCTION.

- 3. THE CONTRACTOR SHALL NOT PERFORM ANY REPAIR WORK WITHOUT PRIOR APPROVAL FROM THE ENGINEER.
- 4. SPALLS, HOLLOW AND SCALE AREAS SHALL BE REPAIRED IN ACCORDANCE WITH "SHALLOW PATCH REPAIR DETAIL" OR "DEEP PATCH REPAIR DETAIL" SHOWN ON DWG. NO. S-05.

- 5. MAXIMUM 15 LB PNEUMATIC HAMMER TO BE USED ADJACENT TO EXISTING REINFORCING TO REMAIN.
- 6. ALL REPAIRS ABOVE THE ORDINARY HIGH WATER ELEVATION.
